Canon 5D Mark III_ Internal Temperature to High

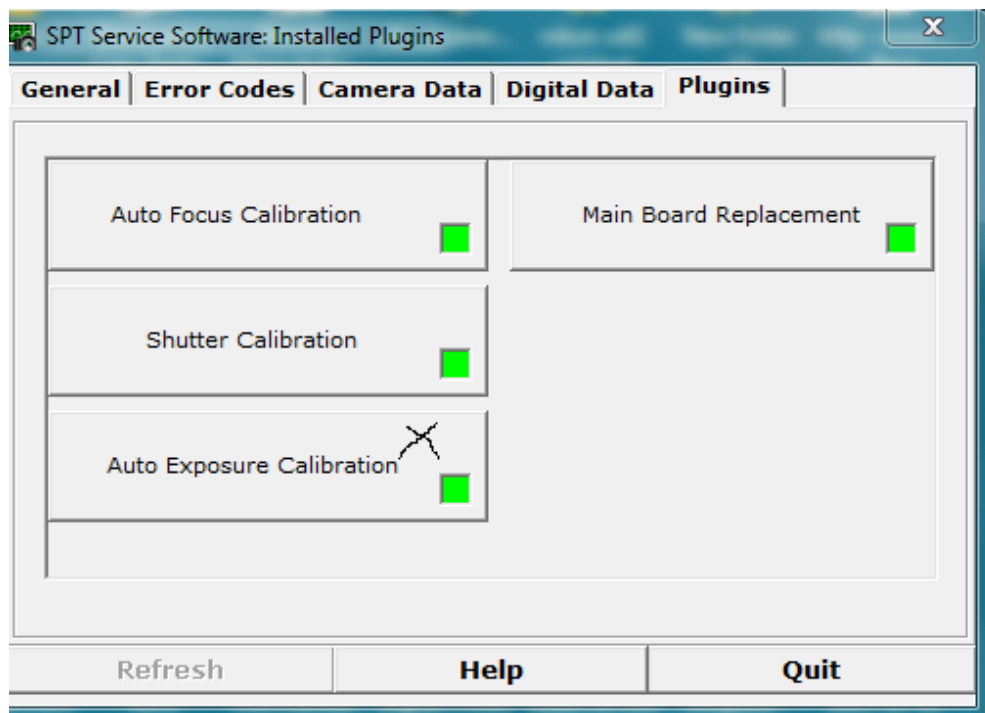
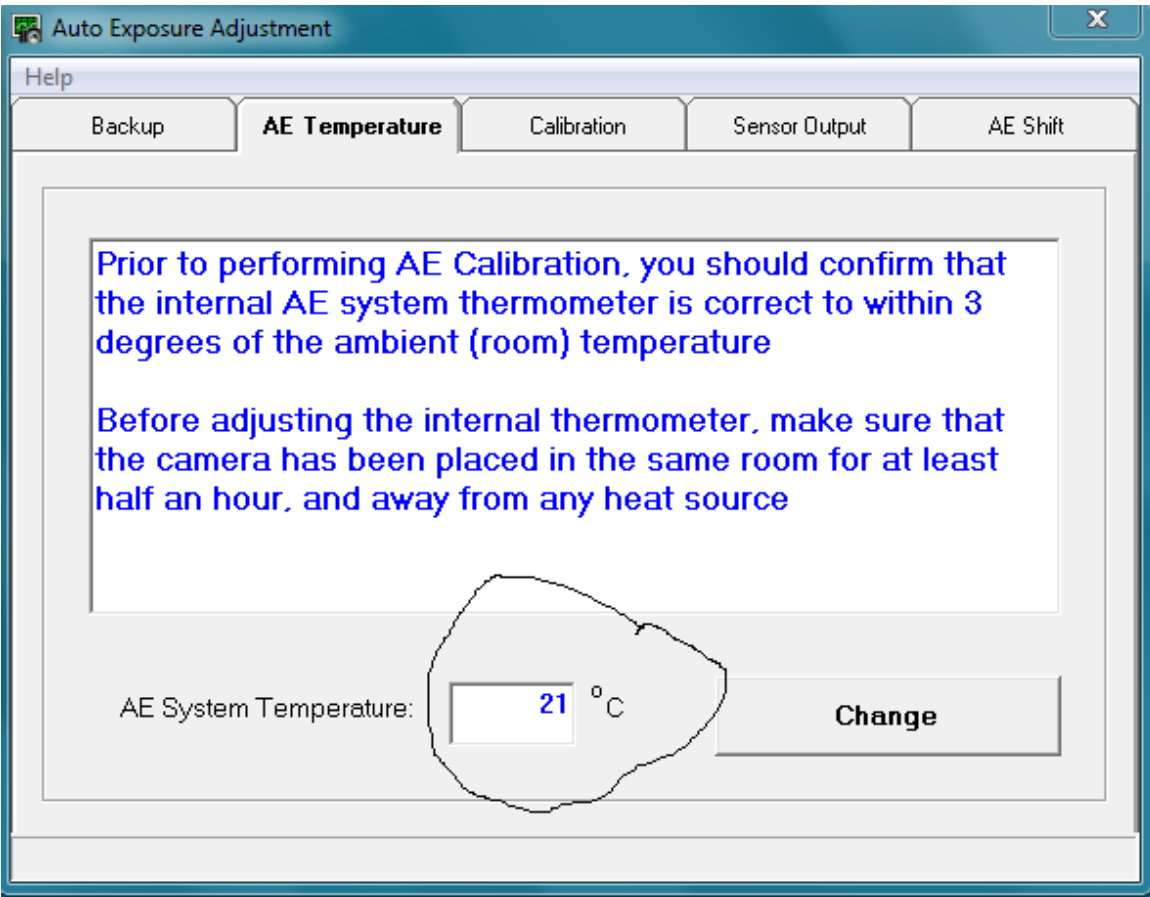
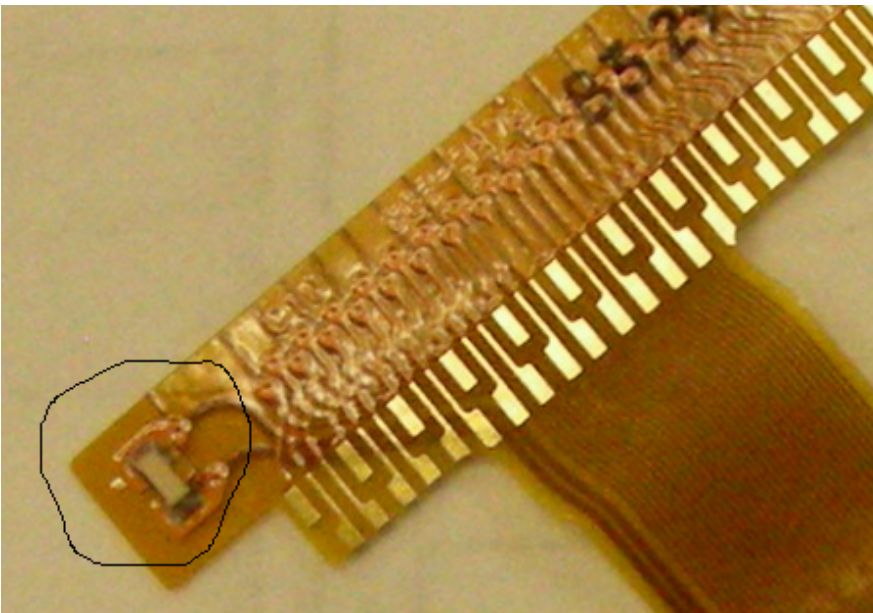
Internal temperature to high, anybody seen this? Shutter or Main PCB?

We found that Canon starting with EOS 40D and the 5D M III, has the internal heat sensor on a most unusual place. on the prism unit on the in-finder LED fpc after replacing the prism problem solved. The reason we ordered a prism unit, the in-finder LED is not available separately.
